DEPARTMENT OF TRANSPORTATION

Contract #: 04-0120F4Cty: SF/ALA Rte: 80 PM: 13.2/13.9File #: 69.28**WELDING INSPECTION REPORT****Resident Engineer:**Siegenthaler, Peter**Address:** 333 Burma Road**City:** Oakland, CA 94607**Report No:** WIR-018918**Date Inspected:** 27-Dec-2010**Project Name:** SAS Superstructure**OSM Arrival Time:** 700**Prime Contractor:** American Bridge/Fluor Enterprises, a JV**OSM Departure Time:** 1900**Contractor:** Zhenhua Port Machinery Company, Ltd (ZPMC), Changxing Island **Location:** Shanghai, China**CWI Name:** Li Yang**CWI Present:** Yes No**Inspected CWI report:** Yes No N/A**Rod Oven in Use:** Yes No N/A**Electrode to specification:** Yes No N/A**Weld Procedures Followed:** Yes No N/A**Qualified Welders:** Yes No N/A**Verified Joint Fit-up:** Yes No N/A**Approved Drawings:** Yes No N/A**Approved WPS:** Yes No N/A**Delayed / Cancelled:** Yes No N/A**Bridge No:** 34-0006**Component:** OBG Segment**Summary of Items Observed:**

TOWER # BAY 10 (Lift 4 south)

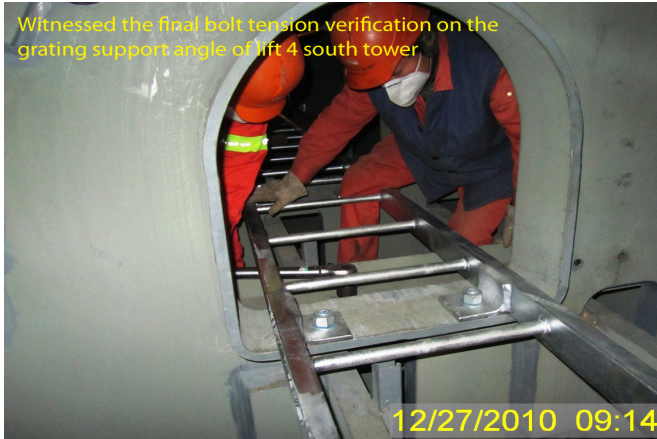
This QA Inspector witnessed the final bolt tension verification on the grating support angle of lift 4 south tower. The torque wrench S/N was 1003153. The QA Inspector witnessed 10% of the bolts on a random basis and found the tensioning of the bolts appeared to be in general compliance with the contract specifications. The bolt size designations were as follows:
